NZ Lifelines 2020

Fixing our ageing wastewater networks

Steve Hutchison – Chief Advisor Wastewater

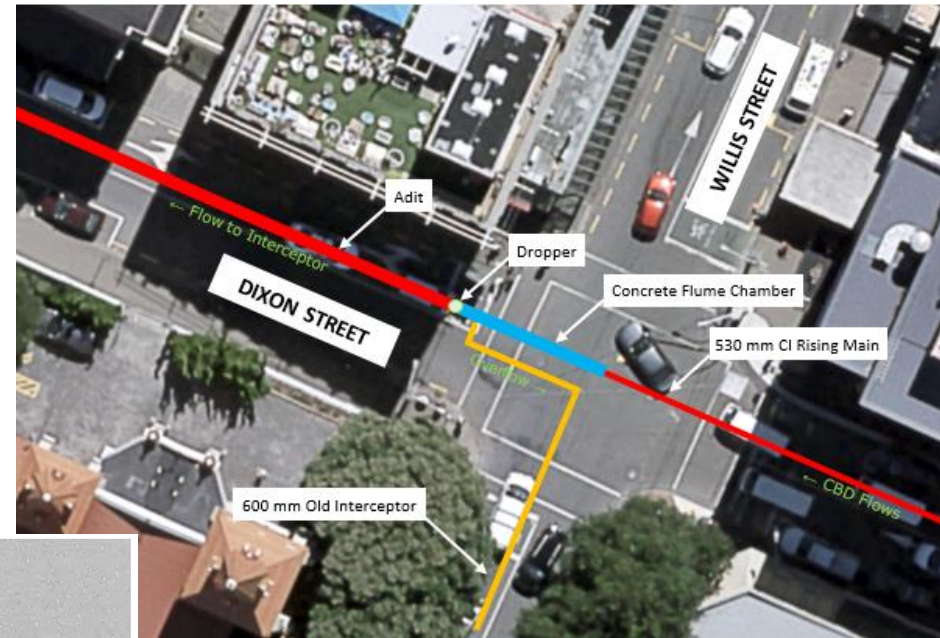
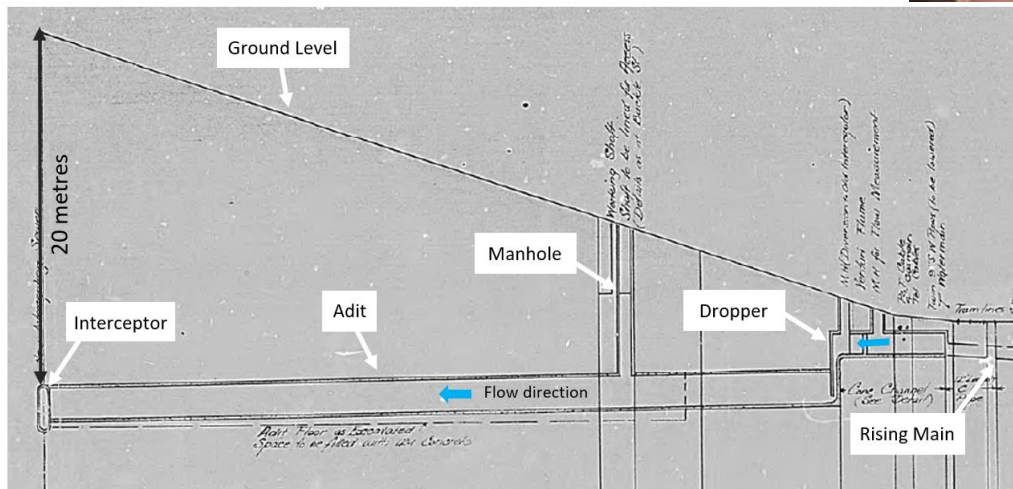
Started as odour investigation

- Odour investigation located leak under Dixon/Willis St
- Rising main connected to “New” 1937 Interceptor
- Original interceptor abandoned in 1980’s

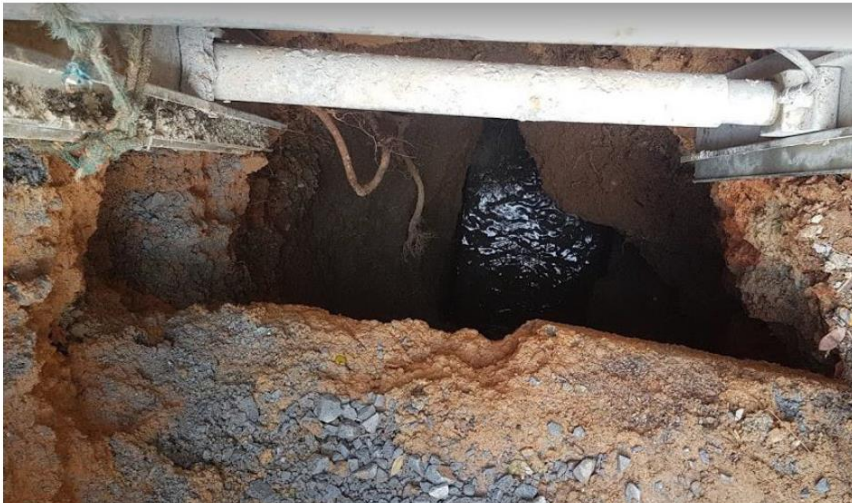
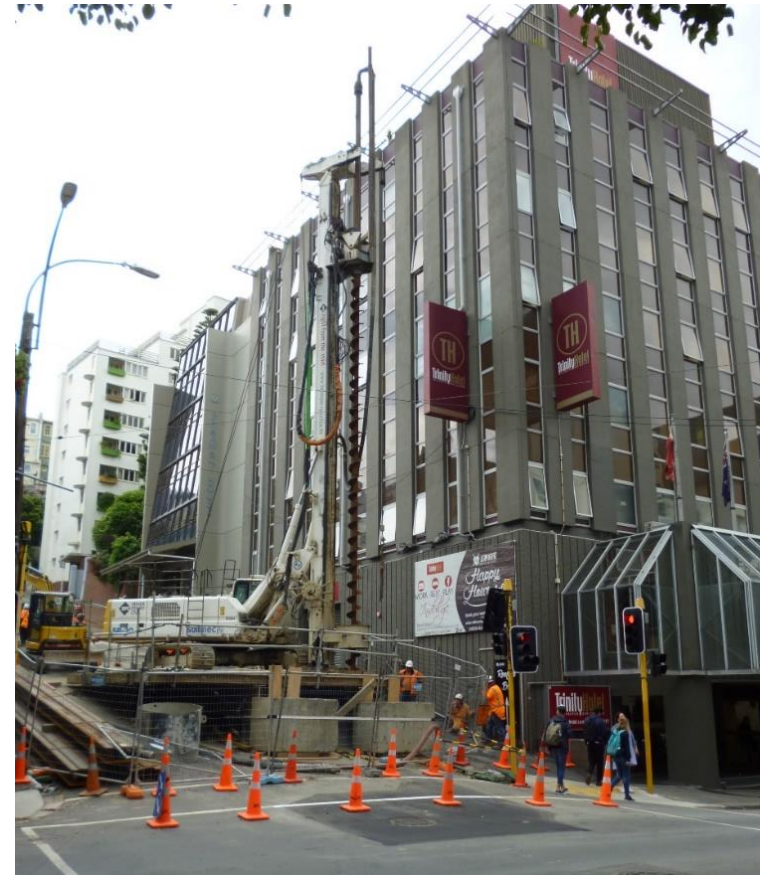
Void lead to collapse

- Potholing nearby revealed void
- Efforts to stabilise void were unsuccessful
- Turned off pumps to stop sluicing and undermining buildings

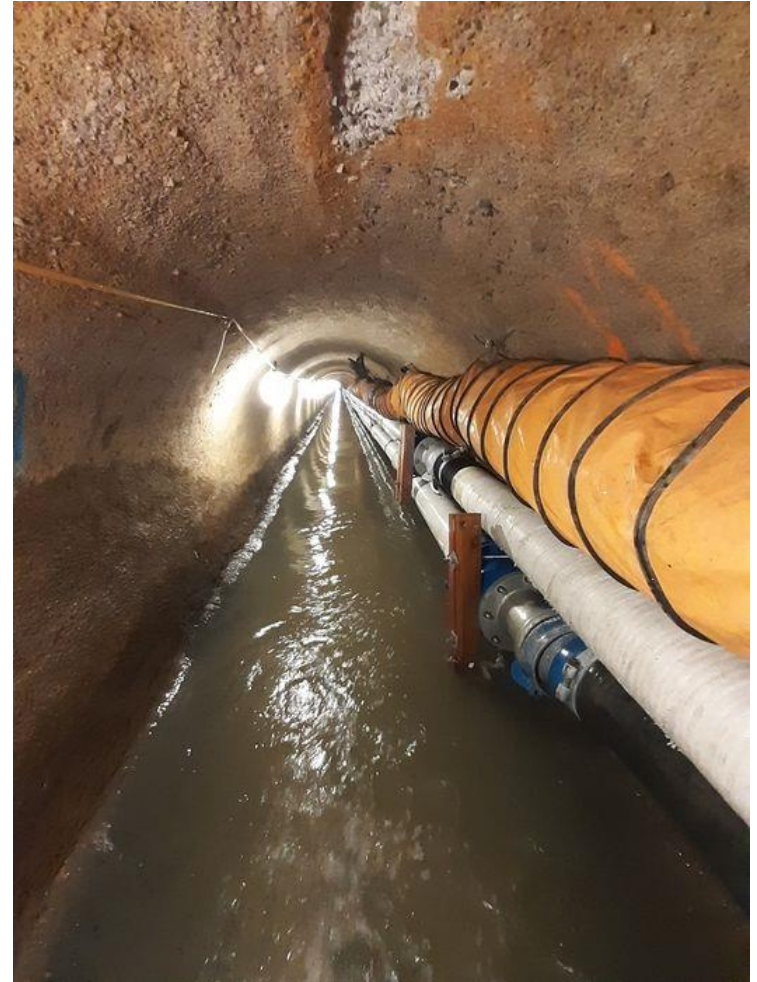
Extremely challenging environment

- Leak located to Mt Albert tunnel
- Mt Albert Tunnel also conveys wastewater
- No alternative flow path
- Sludge pipes encased in concrete
- 1780m long tunnel
- Locating the breaks was difficult
- Fixing them was even harder

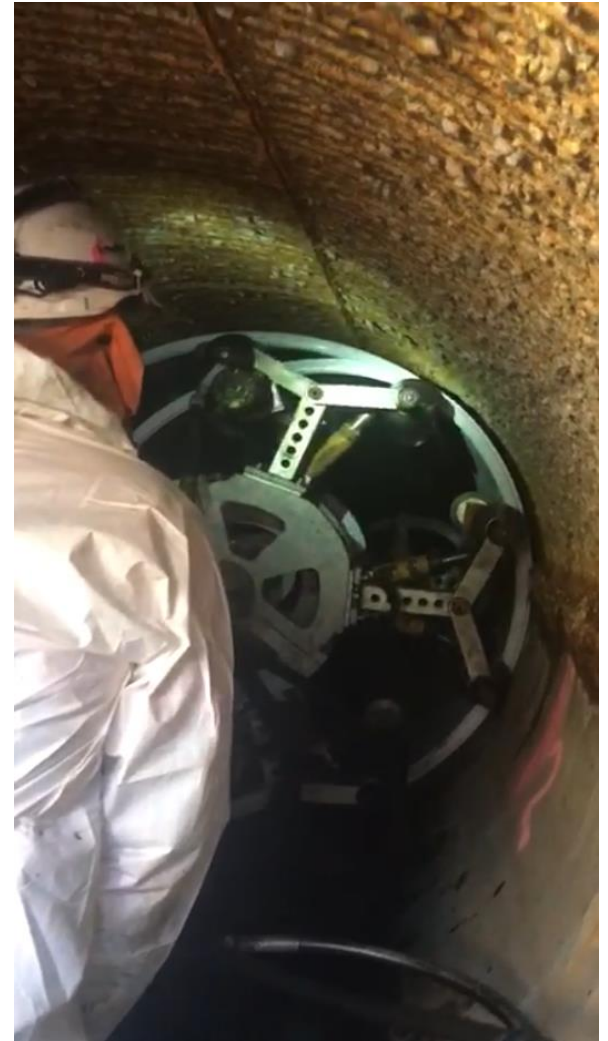
Moa Point Inlet pipe deterioration

- Condition inspection found deterioration in 2013
- Re-inspected in 2018, had got worse
- Required urgent structural rehabilitation
- Internal PVC lining wound in place

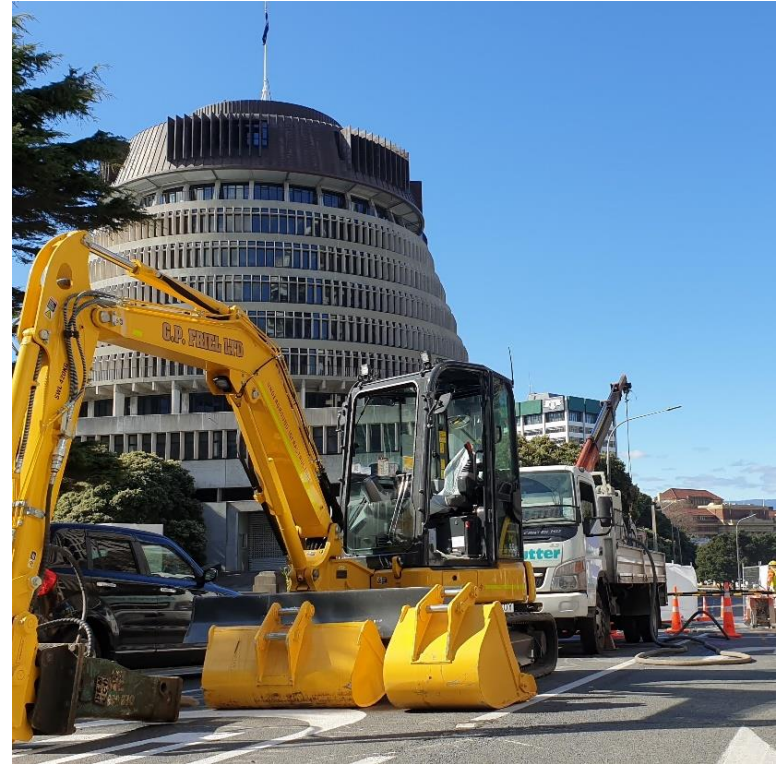
Proactive replacement critical mains

- Northern CBD rising main failures 2010
- No redundancy for planned renewal
- Laying a new rising main on different alignment
- Underground services congestion
- Traffic management challenges
