NZ Lifelines 2020

Fixing our ageing wastewater networks

Steve Hutchison – Chief Advisor Wastewater

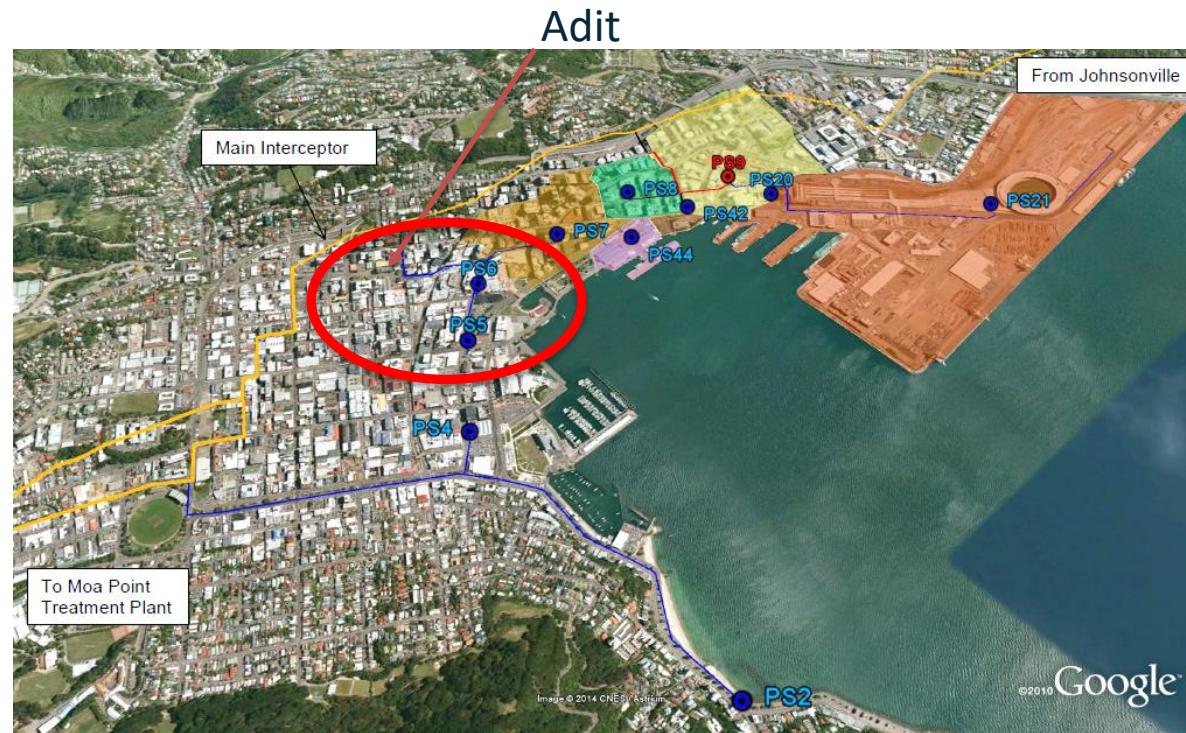
Dixon Street collapse

- Dixon Street serves key CBD area
- 5 million litres/day

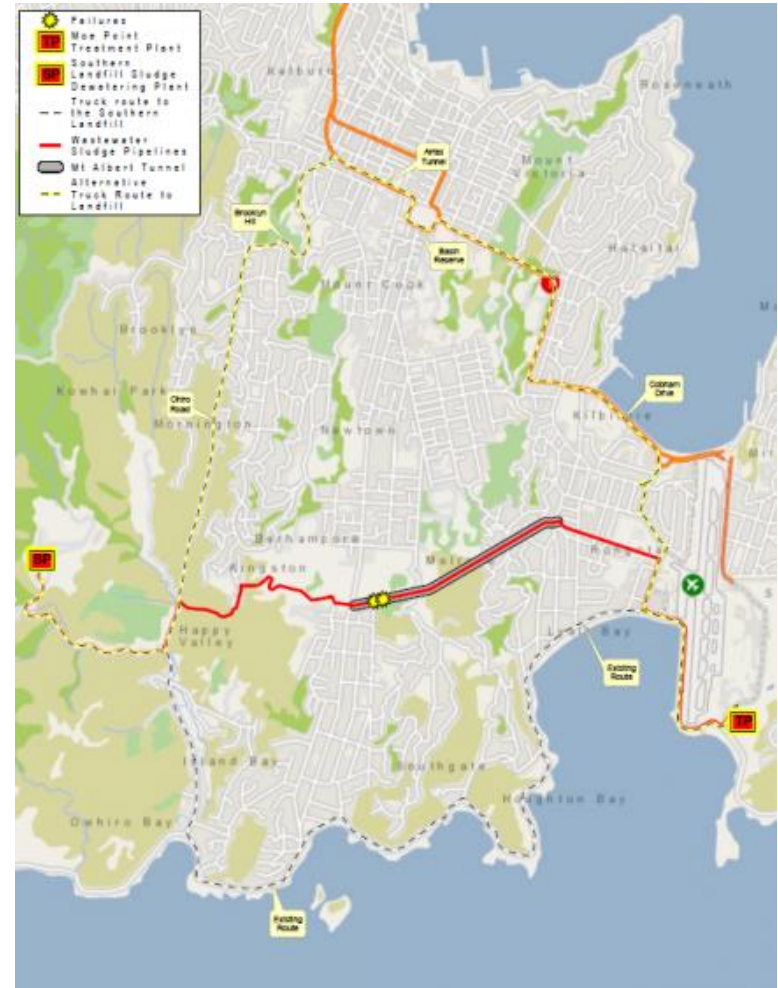
Mount Albert tunnel sludge pipeline

- Sludge pumped 8km to landfill
- Duty/standby 150mm pipelines
- 220m operating pressure
- Both failed late January 2020

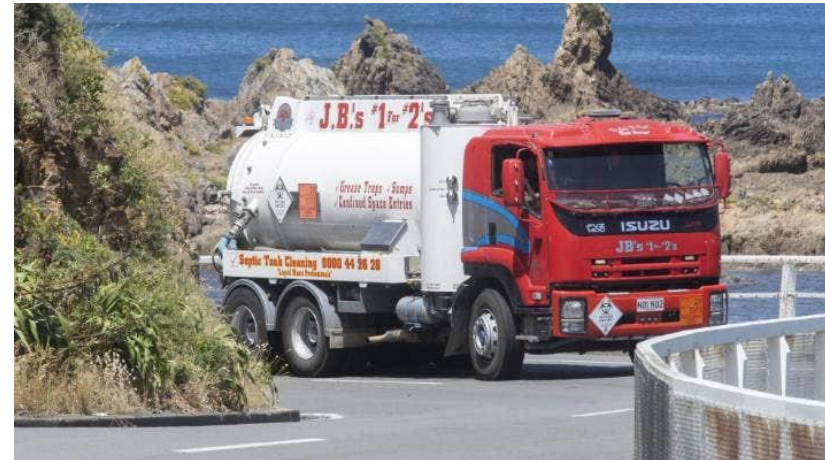
Keeping the sludge moving

- 1,110 million litres sludge per day
- 10 km road trip
- 120 tanker loads a day
- 24 hour operation
- Urgency to fix or replace pipes
