**Auckland Engineering Lifelines Group
Project AELG-19**

**Review of Impacts of Volcanic
Ash on Electricity Distribution
Systems, Broadcasting and
Communication Networks**

Technical Report No.051 April 2009

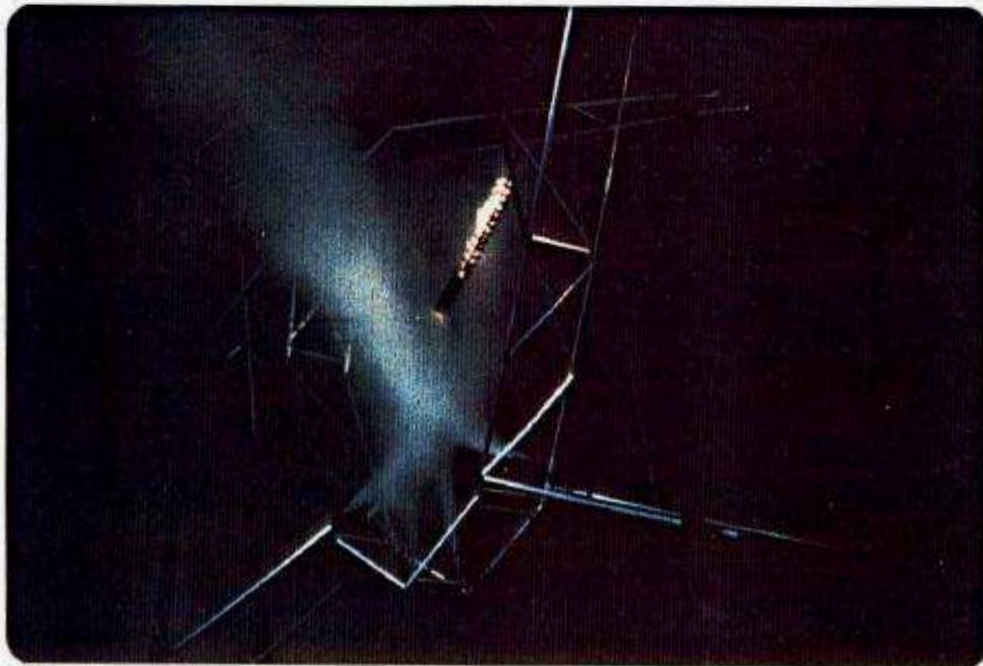
FIGURE A3: Photographs from Nellis & Hendrix (1980) showing (a) setup for testing 500 kV Vee string, and (b) current scintillation (flashover) activity for ash contaminated insulators with steam fog at 1.9 PU applied voltage.

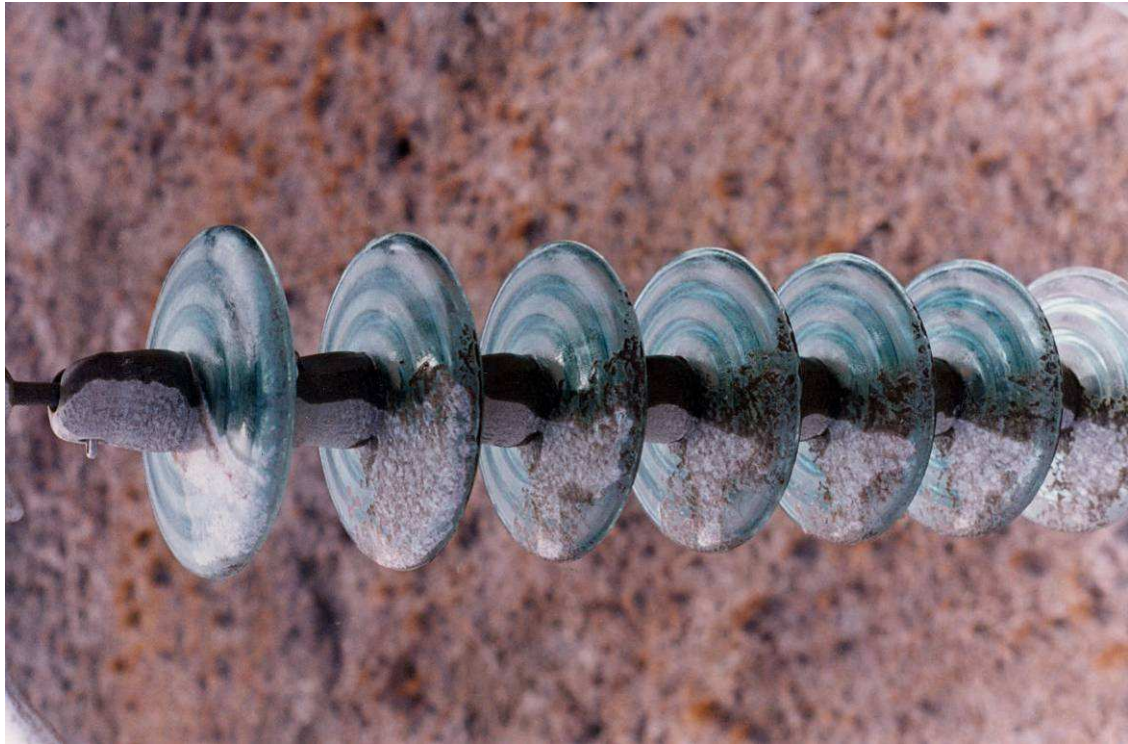
FIGURE A4: Flashover damage from falls of volcanic ash and mud on 25 September 1995 caused on high-voltage electrical power lines at the base of the volcano (from Powermark 1995, unpublished, *"Report on volcanic ash contamination"*).

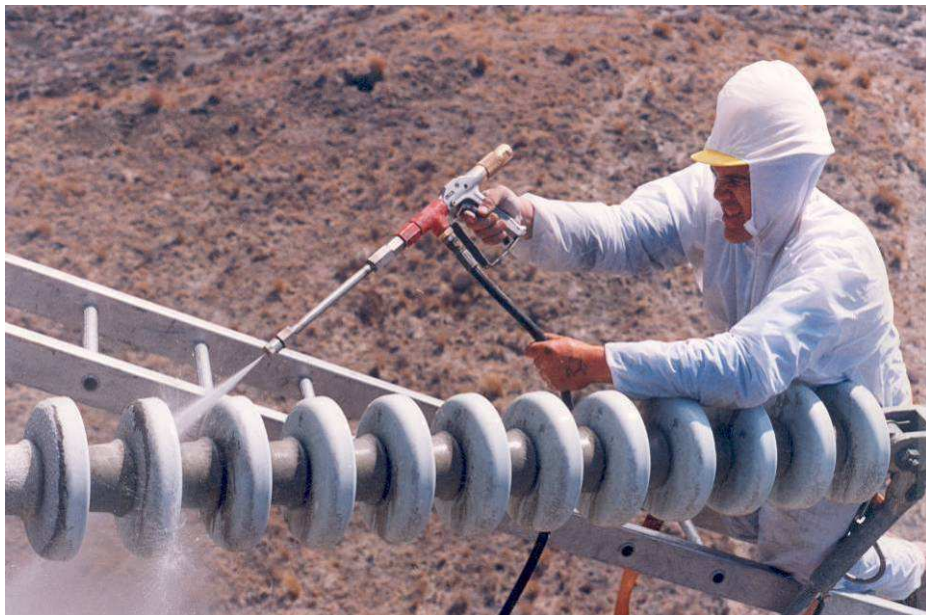
FIGURE A5: Cleaning the power lines/pylons

Electricity supply companies were required to hand clean insulators and towers following every ash fall event (Johnston et al 2000) and towers required repainting afterwards to reduce the acid-induced accelerated corrosion (Figure A5). In addition, the auto recloser system used by the main lines company, Transpower, which breaks electrical supply to a circuit when there is an earth or fault, had to be operated manually during the 1995–1996 eruptions of Mount Ruapehu (A. Joosten, pers. comm 2006). A major concern at the time was that ash fall could cause one circuit to trip out of service, leading to a cascade tripping of remaining circuits transmitting electricity to the upper North Island (Bebbington et al. 2008). Cleaning of 18 towers (and insulators) was undertaken on 27 September 1995 by four crews of four men (Powermark 1995). The ash was found to be dry and easy to remove. Strain towers were the most affected due to their insulator configurations (i.e. horizontally strung). It was found that subsequent rains (on 26 September 1995) had washed the northern side of towers and insulators. It was concluded that normal rainfall would clean ash from structures, conductors and insulators except the undersides of strain strings. Three strings of insulators were found to have widespread flashover damage but with no electrical problems.

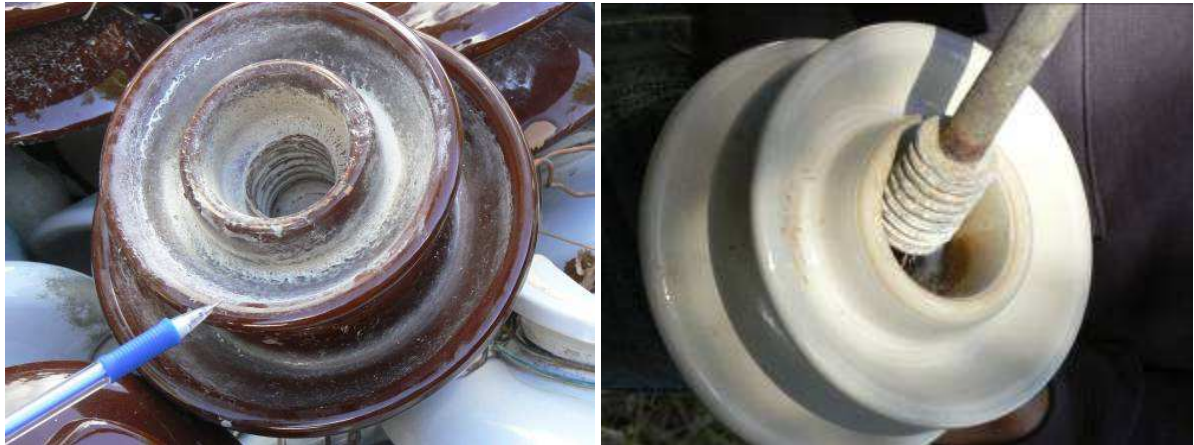
Figure A6: Insulators used on 33 kV line, with ash contamination (left) and flashover damage (right)

A 68 km stretch of 33 kV line to Futaleufu (75 km from volcano) was affected by fine grained rhyolitic ashfalls between 20 mm to over 300 mm in some areas. Local linesmen reported that 10-20% of insulators (porcelain) suffered flashovers from fine volcanic ash accumulation following light misty rain between 6-9 May 2008. The ash covered lines and insulators had operated without problem until the light rainfall. Subsequent heavy rain had reportedly washed much of the ash off, but significant volumes of ash remained underneath insulators where flash-over strikes had occurred (Figure A6). Following initial inspections, the lines company decided to totally replace all insulators on the line, as it was too laborious to clean or assess damage to each insulator. Many of the insulators which had suffered flashover were cracked and exhibited burn marks at the base where it screwed onto the supporting metal pin (Figure A6). Only vertical insulators suffered flashover. Horizontal string insulators did not suffer problems. Isolators and transformers on the line were also reported to have suffered flashover damage. It took 20 days to repair the line.

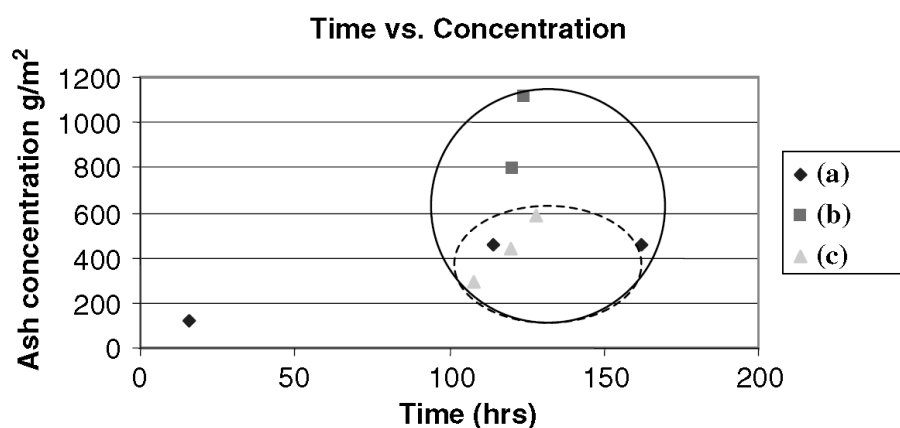
FIGURE A8: Time (hrs) versus concentration of ash (g/m²) for computers crashing (from Gordon et al. 2005).

Three computers were tested in the sealed box. Ash was introduced at increasing rates, with computers tested throughout using the BURNIN_ testing programme which placed extreme work requirements on the computer (Gordon et al. 2005). After initial tests failed to produce computer crashes, tests were conducted using volumes of ash well in excess of that would normally be expected to enter facilities, unless there was a complete collapse of roof sections and catastrophic entry of ash. Failure times ranged from 100 to 150 h following multiple runs of the three computers used (Figure A8). Most failures occurred when humidity was increased by spraying water mist into the airflow. Significantly, if dried out the computers continued to operate again if failure was not catastrophic. Card slot edge connectors proved to be one of the weakest links, as a bridge of ash formed across the gap (Figure A9). They were also subject to abrasion with some of the gold plating being removed. This did not however cause operating difficulties.

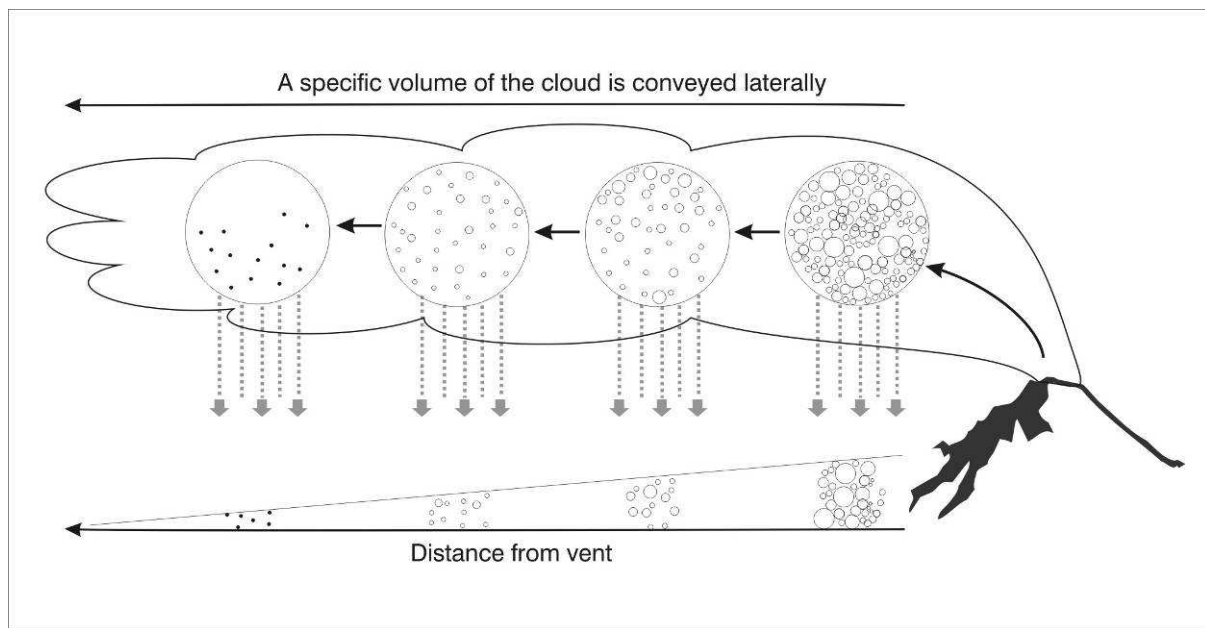
FIGURE A12: Schematic illustration of the fall-out of particles from an umbrella eruption cloud showing decreasing thickness and mean grain-size with distance from source.

Thickness and Particle Size: It is well known that thickness and median grain-size of ash deposits generally decrease exponentially with distance from a volcano (Walker 1971). The distribution of ash (Fig. A1) will depend on the initial grain-size distribution of the ejecta (reflecting fragmentation during the eruption), dynamics of the eruption column and the column's interaction with wind (Carey & Sparks 1986, Bursik *et al.* 1992, Sparks *et al.* 1992, Koyaguchi 1994). Pyle (1989) and Fierstein & Nathenson (1992) have shown that pyroclastic fall deposits display an exponential decrease in thickness with the square root of the area enclosed within an isopach contour.
