Tsunami Impacts to Lifelines:

Learning about Tsunami Impacts on Infrastructure from Recent Events

Nick Horspool (GNS Science)
Stuart Fraser (World Bank)

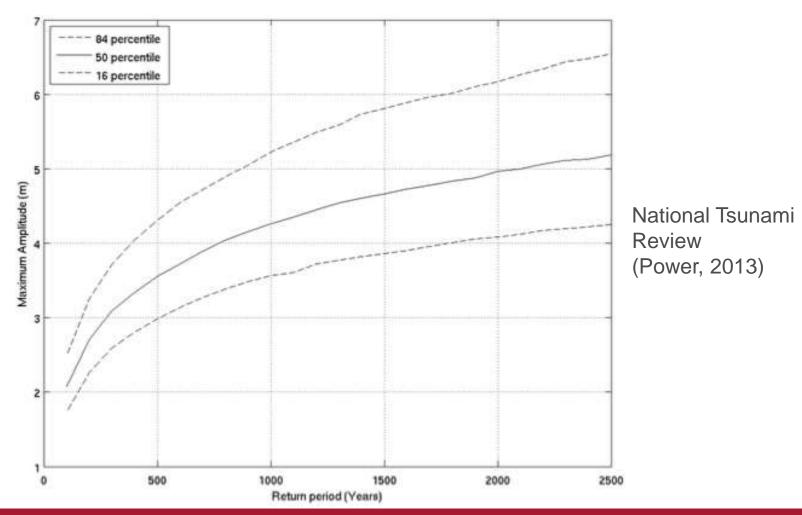
Auckland's Tsunami Hazard

Maximum offshore tsunami height (above still water)

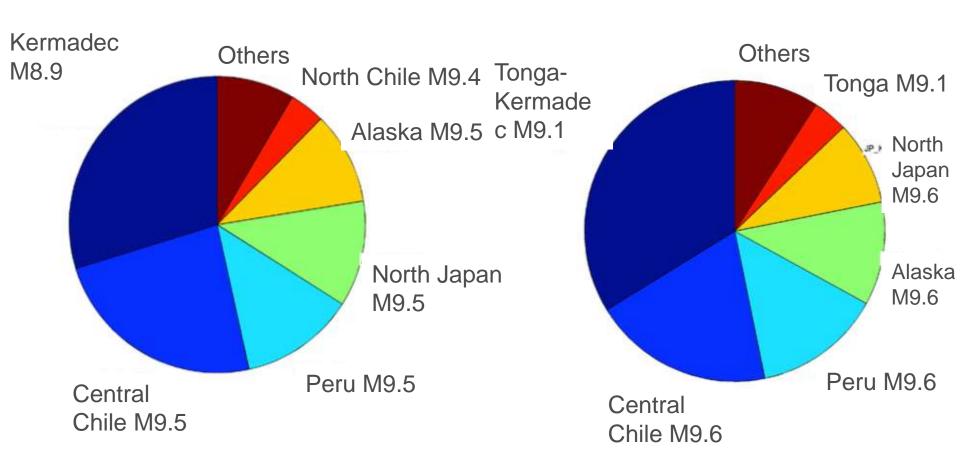
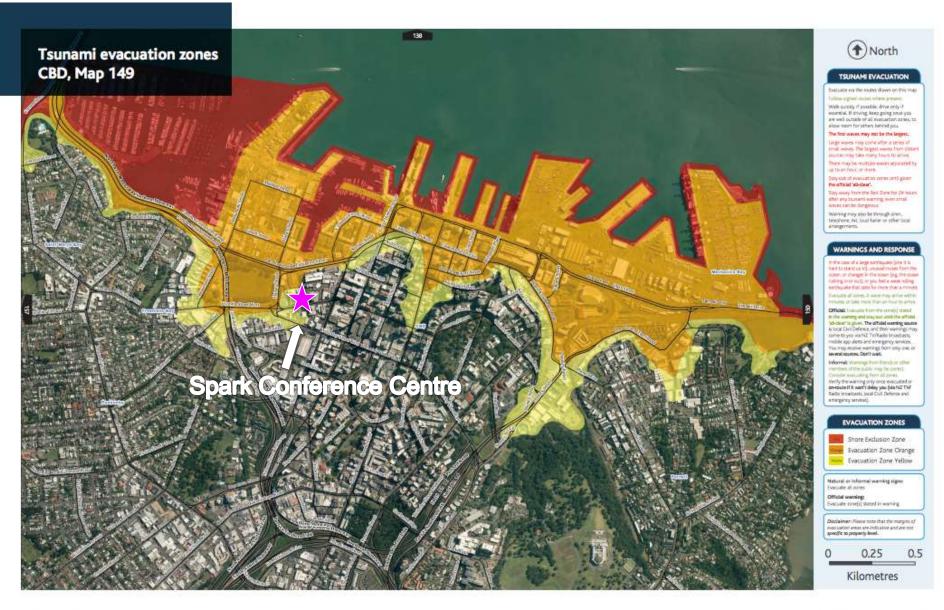
Auckland's Tsunami Hazard – Where Does it Come From?

1 in 500 Year: 3.5 m 1 in 2500 Year: 5.2 m
