VOLCANIC ASHFALL

ADVICE FOR ROAD NETWORK OPERATORS

Ash Impacts On Road Networks

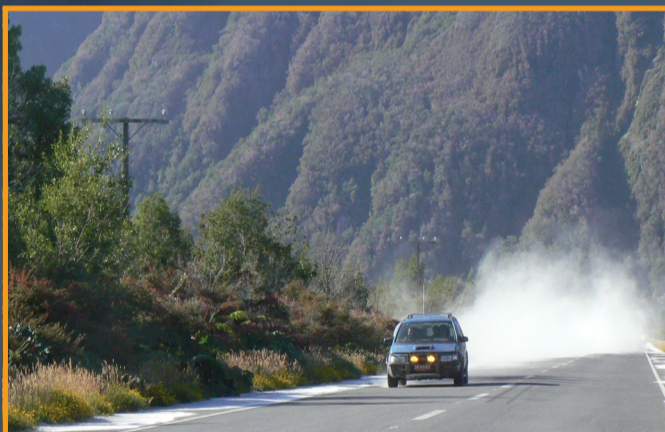
Volcanic ash lifted by vehicle near Chaitén volcano, Chile

- Impacts can continue after eruptive activity has ended due to the remobilisation of ash by wind, water, traffic and/or other human activity.
- Ash remobilised in rivers and creeks can lead to lahars (volcanic mudflows) causing damage to bridges and other infrastructure.

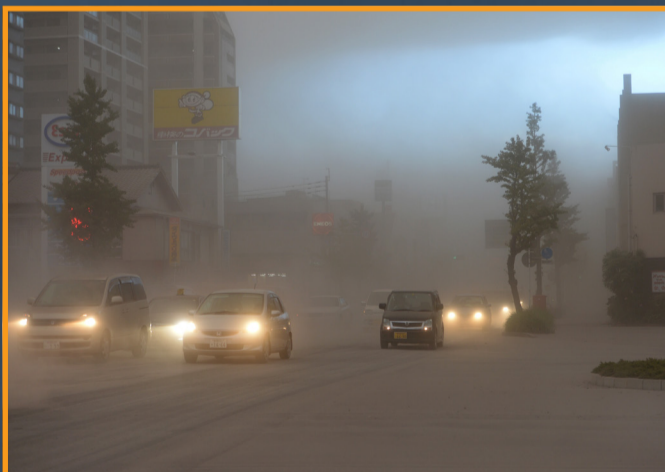
Reduced visibility and covered road markings in Kagoshima City due to ashfall from Sakurajima volcano, Japan (photo credit: Minami Nippon Shimbun, Kagoshima, Japan).

- Visibility can be severely reduced during and after an eruption due to ash suspended in the air.
- Traction on ash-covered roads is reduced in both dry and wet conditions.
- Road marking coverage can occur when ash is less than 1 mm thick.
- Accident rates will likely increase.
- Vehicle damage may consist of the clogging of filters, corrosion of metal surfaces, and abrasion damage to windscreens, paintwork and moving engine components.
- Roads may become impassable (to 2WD vehicles) when ash on the ground is around 100 mm thick.

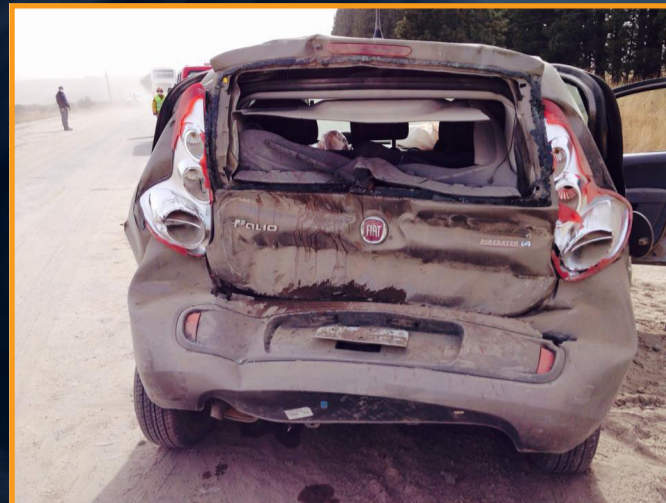
Accident damage in Junín de los Andes, Argentina following ashfall from Calbuco volcano, Chile. (photo credit: Junín de los Andes Fire Department, Argentina)

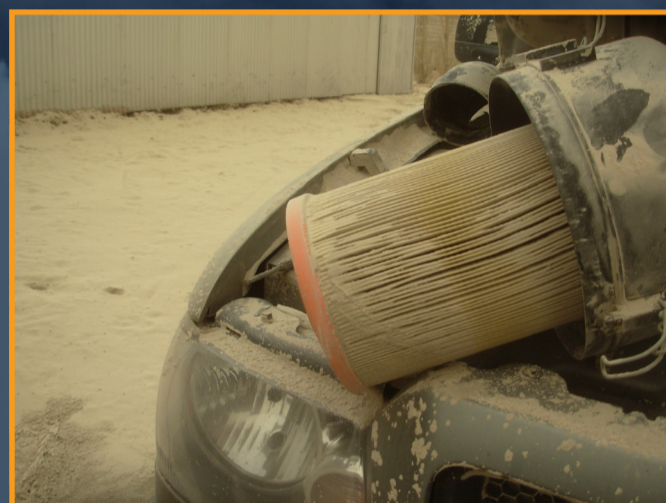
Heavy ash contamination of car air filter following 50 mm of ashfall from the 2011 eruption of Cordón Caulle volcano, Chile. (photo credit: Ailen Rodriguez, Jacobacci, Argentina)

- Avoid using wipers to clear ash from windscreens as this can cause abrasion damage. Rinse ash from windscreens and vehicle paintwork with water.
- Clean or replace air and oil filters regularly.
- Apply lubricant/grease more frequently and check for wear.
